The Deadlywind hAir 45 is a replacement 3-way valve with reduced surface areas and hysteresis overlap (results in a lighter and shorter trigger pull) for the Plant Eclipse EMEK and m170R style guns. The EMEK and m170R version share all the same components with the exception of the aluminum hAir 45 block, which is specific to fit each gun frame.

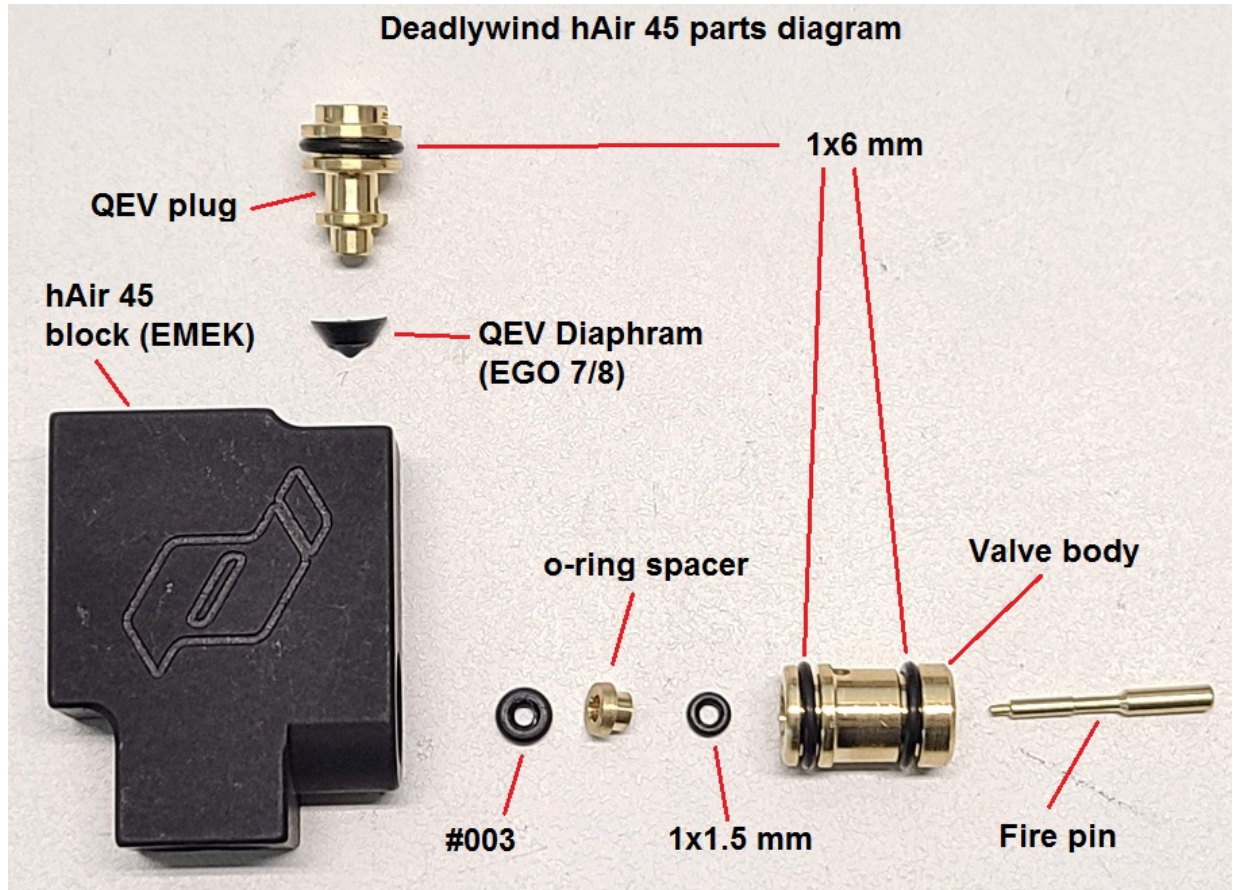
The hAir 45 utilizes a QEVA diaphragm to create a crisp firing event. The QEVA also creates the famous "farting" noise when degassing the gun. This is normal. All components are held in with O-ring friction and should be easily removable. At times, a few sharp downward-facing raps against a workbench edge to dislodge a component is required before removal.
